T PLATE B D

*D series-double wall brazed plate heat exchanger
A visible safety solution*

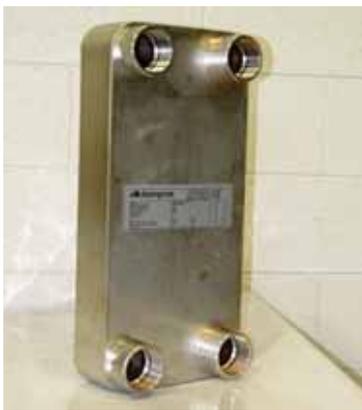
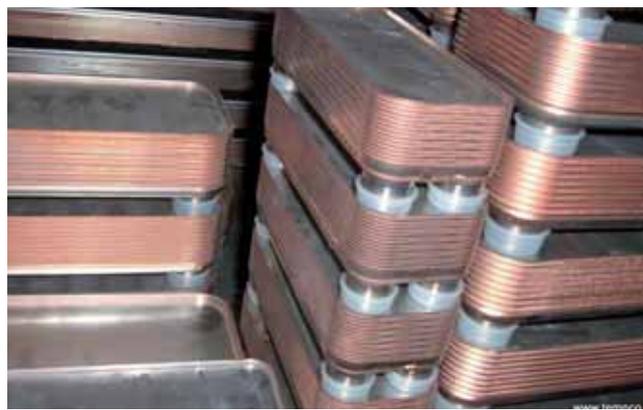
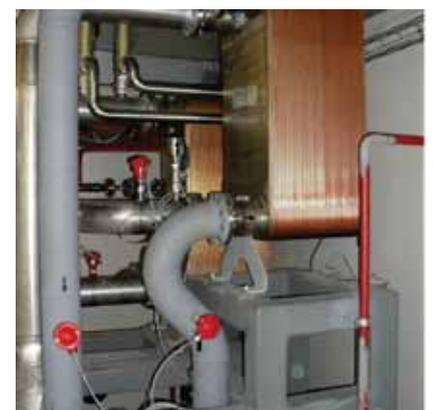
Connectors

1 1/2"
Male Thread

1 1/4"
Female thread

Soldering
Ø35.25 mm
