TECHNICAL SHEET  
T PLATE B D

*D series-double wall brazed plate heat exchanger  
A visible safety solution*

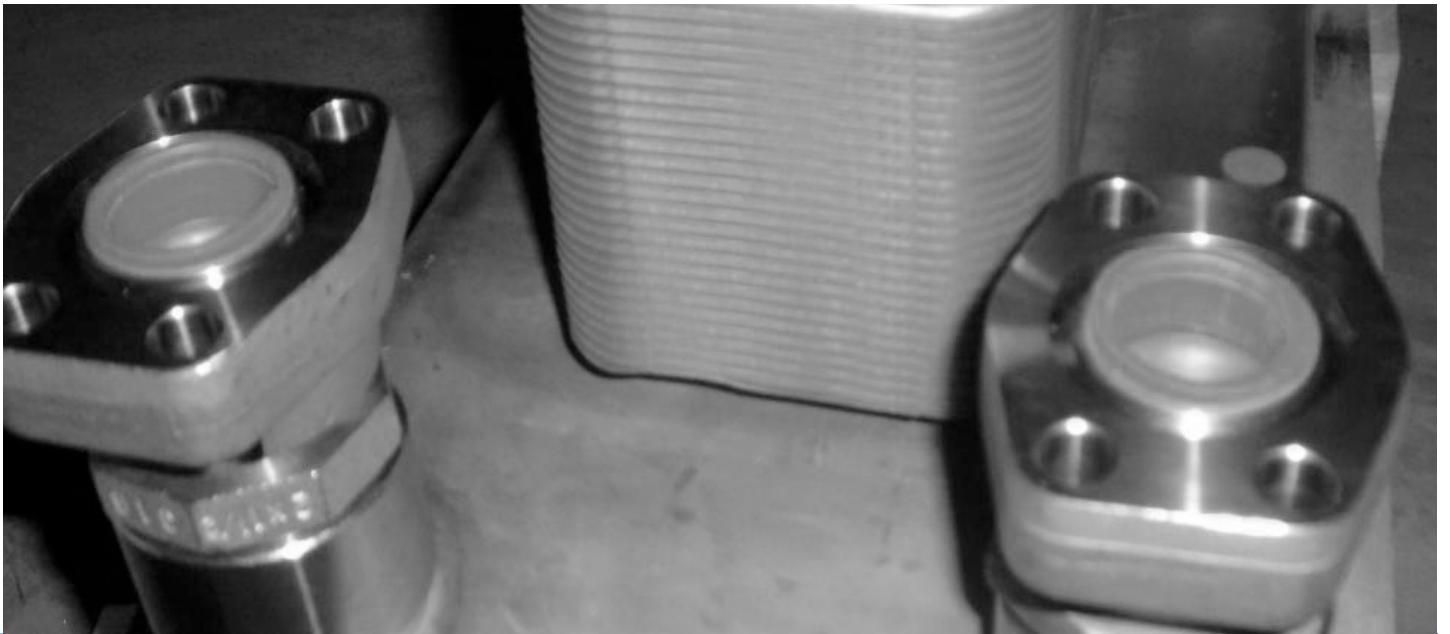
In prevention of two different kinds of fluid from intermixing caused by internal leakage, Tempco precisely designed the TCBDW900CUK solution with the double-stacked plates, to eliminate the possibility of cross contamination.

The unique air gap is created between the two plates. Once the internal leakage occurs, the 2nd plate becomes the shield to keep the liquid stay and flow on the same channel through the air gap. Meanwhile, vent holes outside the plate will seep out the liquid as an indication of leakage. The patented plate design construction can greatly raise and enforce the safety to use Tempco TCBDW900CUK especially for Residential and Industries where require high and strict safety standard; a visible safety solution.
